KEEPING TRACTORS MOVING SINCE 1911 – NATIONAL BRONZE MFG. CO.

Case Study

Bronze Bushings Prove Superior against Plastic Substitutes

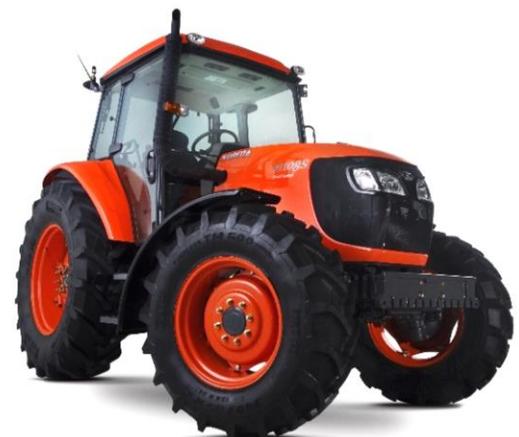
The flanged plastic bushings in our customer's tractor was just the case. We suggested a new bronze bushing manufactured from oil impregnated bronze. This bushing will add strength and wear resistance to the part as well as self-lubrication due to the impregnated oil in the SAE841 Bronze alloy.

This product being a powdered metal product is generally manufactured in high volume. In order to utilize the benefits of the P/M product and avoid the unnecessary inventory, we machined the replacement parts from oil impregnated bar stock.

Oil impregnated bar stock is produced just for this benefit. This material conforms to the SAE 841 specification and generally is produced in 6 1/2" lengths. This type of product gives customers additional options depending on their needs.

Our customer did not have a drawing for this part. So in order to manufacture an exact replacement, we were sent the old bushings as well as the assembly that they are pressed into. By reverse engineering their current components, we were able to make an exact replacement out of bronze bar stock. Now that the part has been programed into our CNC turning centers, it is very easy to replicate these parts for future use. That's the kind of service that you receive when dealing with a company that combines over 100 years of industry knowledge with the latest state of the art machining equipment.

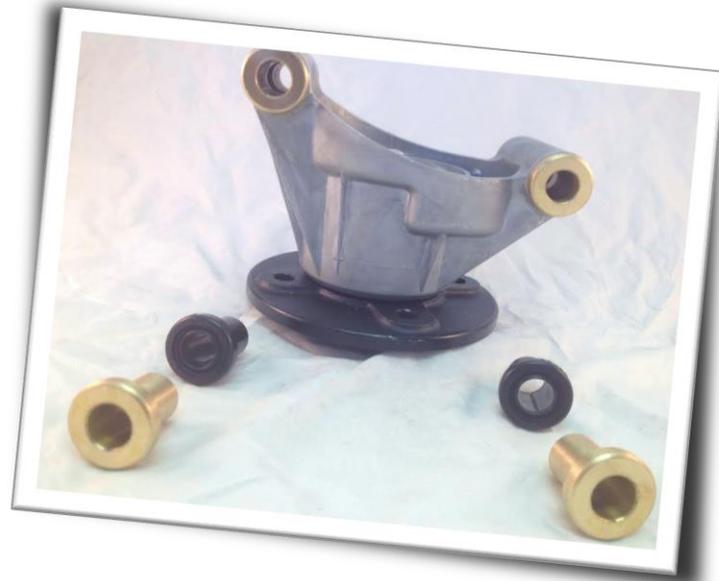
The new bronze flanged bushings worked out great for our customer. The customer's machined part fit perfectly in the assembly. With the bronze bushings replacing the plastic counterparts our customer can spend more time using his tractor for what it was made to do and less time maintaining it.
